Technical Data Sheet

Bridge Identification:	1110570000000B01 1110570000000B02
Facility Carried:	US 31
Feature Intersected:	St. Joseph River
Location:	Niles Township
County:	Berrien
Region:	Southwest
Year Built:	1984
Year Reconstructed:	N/A
Bridge Type:	Welded Plate Girder
No. of Spans:	5 S.B., 6 N.B.
Deck Area:	62,885 S.F. (S.B.) 72,445 S.F. (N.B.)
Paint System:	Type 3 (Fascias Type 4)
Paint Area:	180,500 S.F. (S.B.) 201,000 S.F. (N.B.)

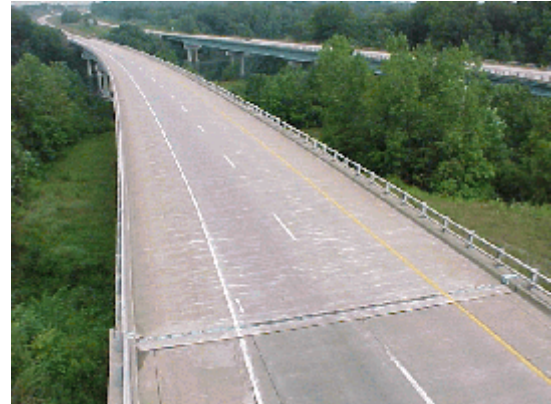
Plan View Looking North (1)

Bridge B01 of 11057 is a five-span continuous welded plate girder bridge carrying U.S. Route 31 (S.B.) over the St. Joseph River in Niles township in Berrien County. Bridge B02 of 11057 is a six-span continuous welded plate girder bridge carrying U.S. Route 31 (N.B.) in the same location. The span lengths vary. The span lengths for B01 are 208'-4", 297'-10", 297'-10", 297'-10" and 208'-3" measured from south to north. The overall length of B01 is 1,310'-1". The span lengths for B02 are 203'-11", 205'-7", 297'-2", 297'-2", 297'-4", and 208'-1" measured from south to north. The overall length of B02 is 1,509'-3". The out-to-out width of the deck is 48'-0" for both bridges, providing for two 12'-0" travel lanes and one 12'-0" and one 8'-0" shoulder. The bridges are supported by reinforced concrete abutments and piers. There are both hammerhead and rigid frame piers at these bridges.

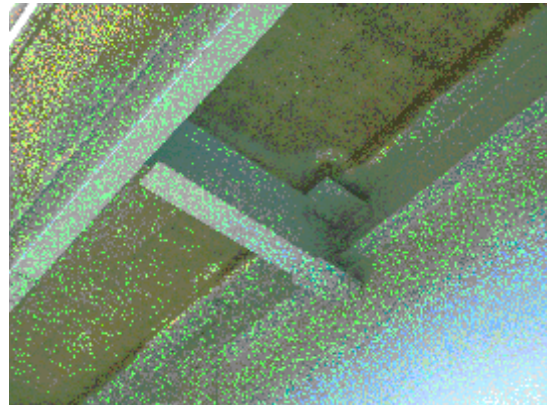
Typical Bracket Framed through Main Girder (2)

- ! **Brackets.** These members are framed through the main girders (Photo 2). Some of the connections occur in the tension areas of the main girders. The bracket members are wide flange steel beams which support the exterior sub-stringers. The bracket connection minimizes out-of-plane web distortions in the main girders. If there is any cracking at these locations, it would first appear in the girder web at the edge of the bracket connections. Monitor the edges of the connection for cracking in the main girder web. In the short spans the longitudinal stiffener passes through the bracket connection.
